Thermal & Home Inspection

Home Inspection Report

**Subject: XXXX Street Place
Anyville, CA 95XXX**

Inspection Date: May 11, 2010

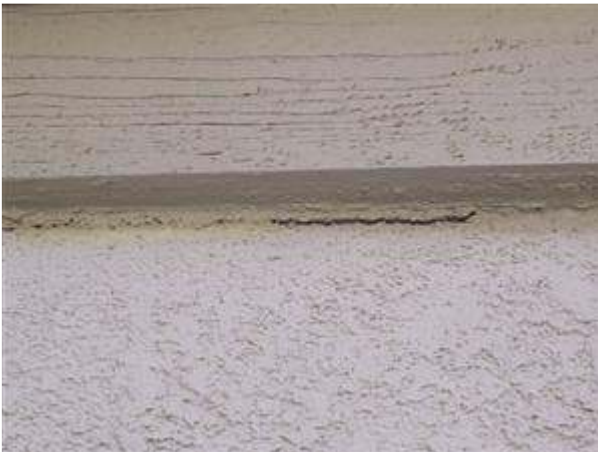
1.0 Picture 1 trim at back of garage

- 🏠 Recommend applying sealant around trim in various areas around house. Evidence of repairs at West side of Entry area. This area shows moisture stains on interior walls.

Recommend applying sealant around trim in various areas around house. Evidence of repairs at West side of Entry area. This area shows moisture stains on interior walls.

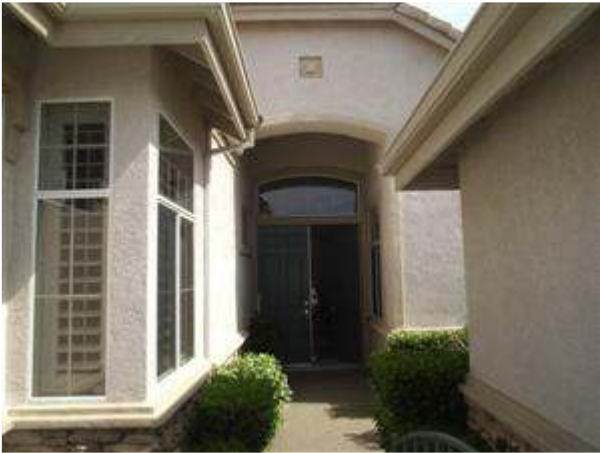
1.2 Picture 1 front entry

View of Entry from front.

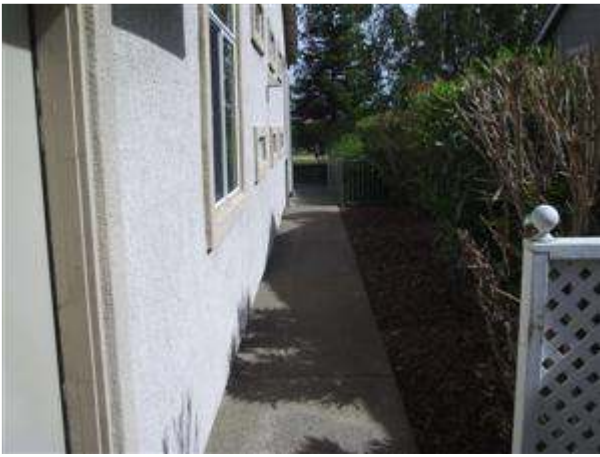
1.5 Picture 1 vegetation

Drainage appears adequate.

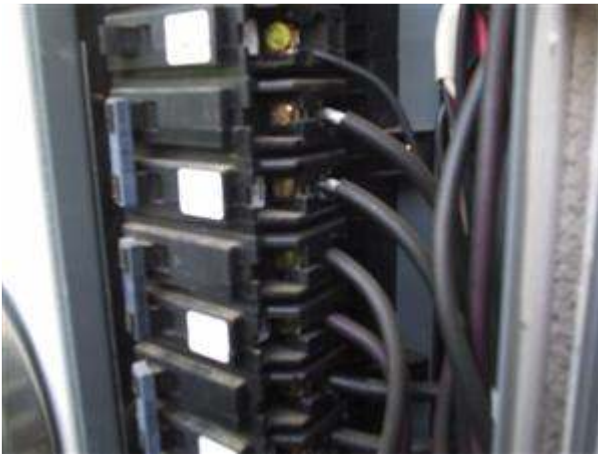
2.2 Picture 1 main panel

Wire size and circuit breaker amperage is good. It was noted that all wire used for 220 volt appliances, is Aluminum wire.

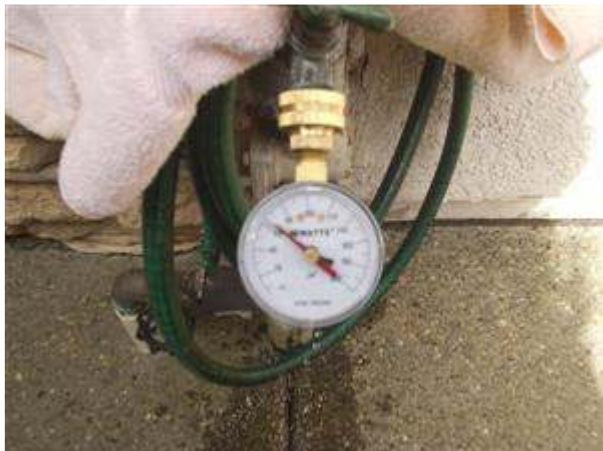
4.0 Picture 1 water pressure at 62 lbs

Water tested at 62 lbs. Pressure regulator is present. Main water shut-off valve in two locations. Valve at SE corner of garage, and another shut-off valve with the water meter, located at the SE corner of the lot.

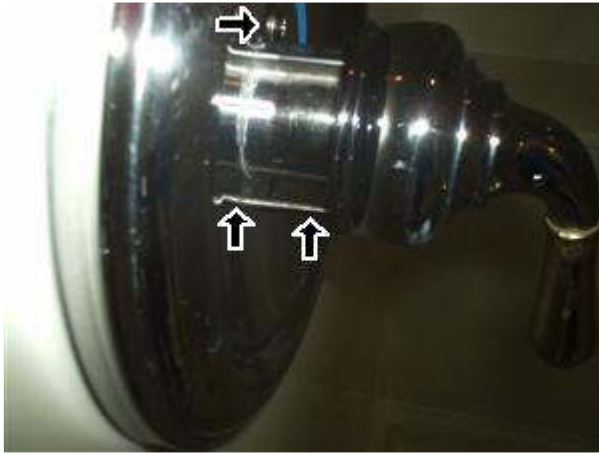
4.2 Picture 1 master shower valve

- 🏠 There is a screw coming out from the control valve cover plate in the master bathroom shower. Supply line for ice maker has a kink in it. No leaks are present at this time, but this is a weak point in the supply line. Toilet in Hall Bathroom is mounted loosely to the floor. Flush handle on toilet in shared Bathroom sticks, allowing water to run continuous. Master bath tub cold water handle is not fixed to the control valve. Recommend repair by a qualified person.

There is a screw coming out from the control valve cover plate in the master bathroom shower. Supply line for ice maker has a kink in it. No leaks are present at this time, but this is a weak point in the supply line. Toilet in Hall Bathroom is mounted loosely to the floor. Flush handle on toilet in shared Bathroom sticks, allowing water to run continuous. Master bath tub cold water handle is not fixed to the control valve. Recommend repair by a qualified person.

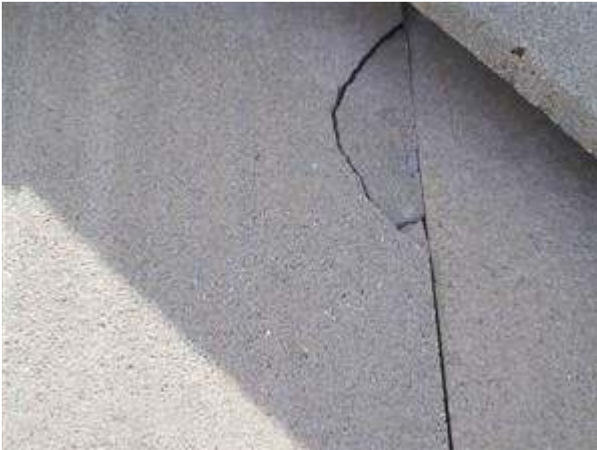
5.0 Picture 1 cracked tile

It was noted at time of inspection, that there are several roof tiles with cracked corners, and a few tiles that are cracked in half. Also noted that a few ridge caps have come loose. Recommend repair by a qualified contractor. Recommend trimming the tree back to clear the roofing.

It was noted at time of inspection, that there are several roof tiles with cracked corners, and a few tiles that are cracked in half. Also noted that a few ridge caps have come loose. Recommend repair by a qualified contractor. Recommend trimming the tree back to clear the roofing.

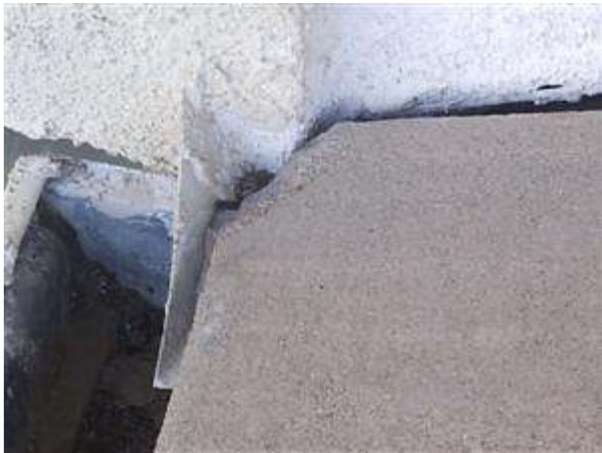
5.1 Picture 1 kick out flashing

Kick out flashings are used throughout.

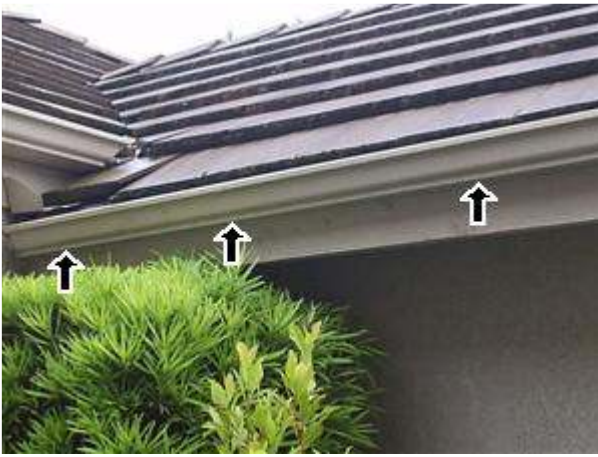
5.3 Picture 1 sagging gutter

- 🏠 Gutter located on the back of the garage, has sagged down on the left side, downspout is on the right side. Recommend repair by a qualified person.

Gutter located on the back of the garage, has sagged down on the left side, downspout is on the right side. Recommend repair by a qualified person.

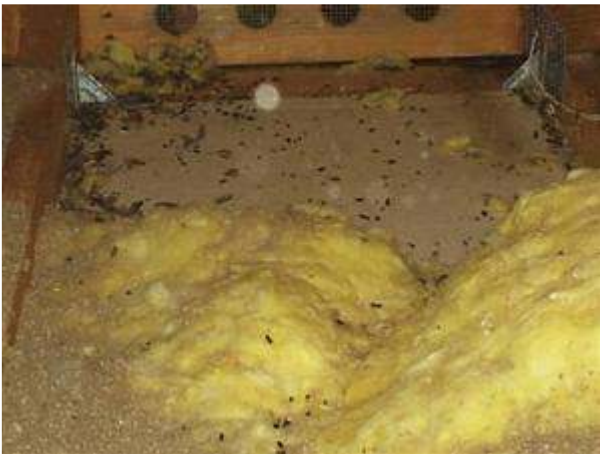
6.0 Picture 1 rodent activity

- 🏠 Rodent activity was noted in the attic area. Entrance is through small holes at rafter framing blocks at the back side of the house. Insulation appears to be blown-in Cellulose, at approximately 10 inches deep (R 30 to R 38). Insulation is thin over the shared bathroom, and is lacking in an area over the family room. Recommend repair by a qualified person.

Rodent activity was noted in the attic area. Entrance is through small holes at rafter framing blocks at the back side of the house. Insulation appears to be blown-in Cellulose, at approximately 10 inches deep (R 30 to R 38). Insulation is thin over the shared bathroom, and is lacking in an area over the family room. Recommend repair by a qualified person.

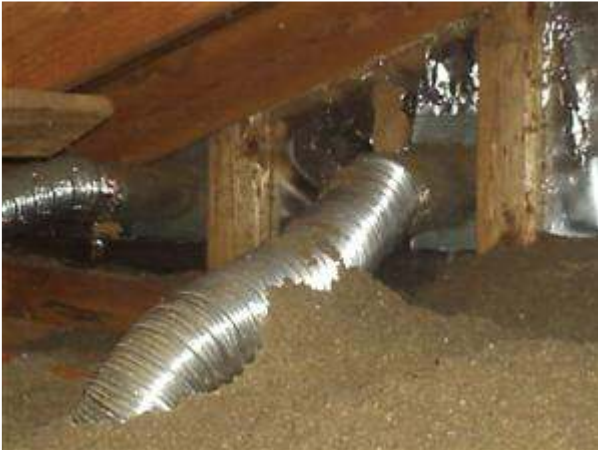
6.3 Picture 1 fan vents

Kitchen, Laundry room, and Bathrooms all have exhaust fans that vent to the outside area.

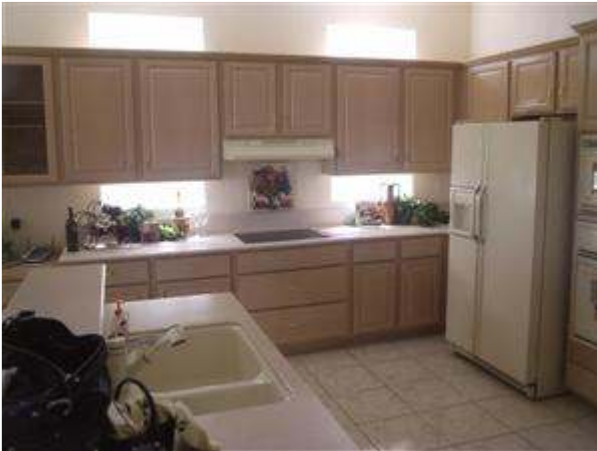
8.1 Picture 1 view of kitchen

All operated as intended, with exception to the Left Front burner. It does not warm up on the LOW setting.

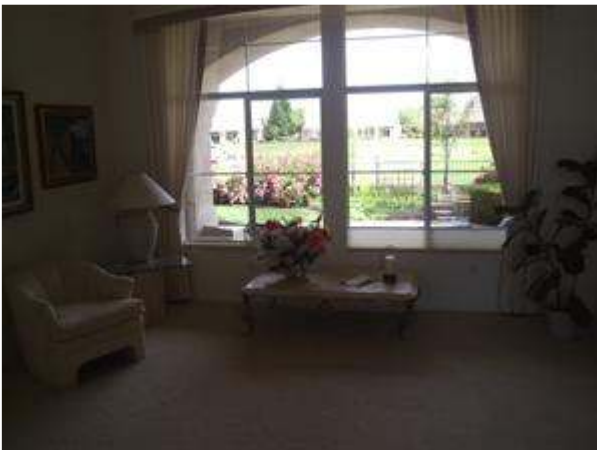
9.0 Picture 1 view of family room

Cracks in ceiling drywall in various areas appear to be settling cracks, and not structural.

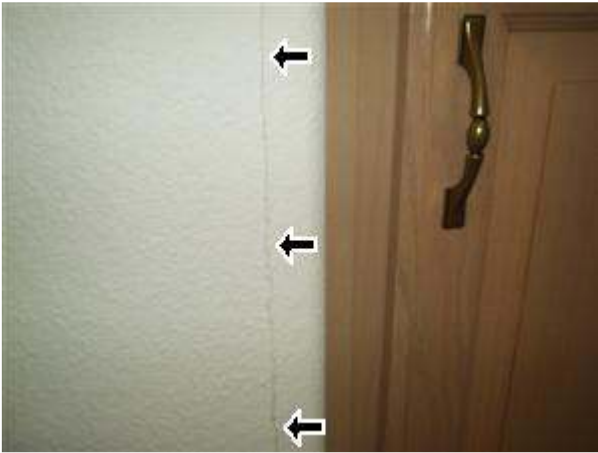
9.1 Picture 1 dining room

🏠 Various settling cracks noted to wall corners. Moisture stains noted in the SE bedroom at the baseboard. Moisture was apparently intruding from beneath the gutter on the exterior of the wall. A repair has been completed for this area.

Various settling cracks noted to wall corners. Moisture stains noted in the SE bedroom at the baseboard. Moisture was apparently intruding from beneath the gutter on the exterior of the wall. A repair has been completed for this area.

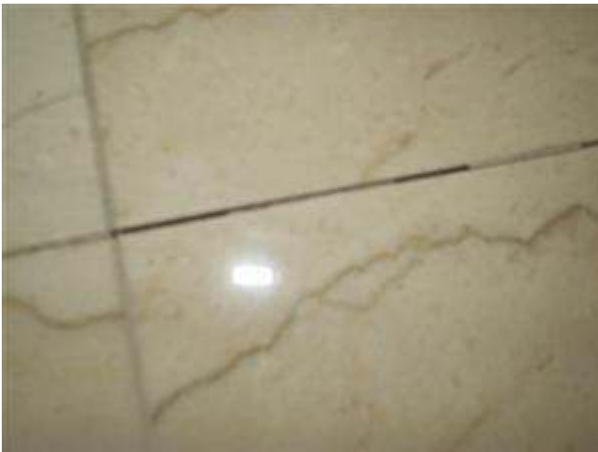
9.2 Picture 1 missing grout

🏠 Tile at entry is missing grout in a couple of lines. Grout is water stained in the low lying area of the patio. Unable to determine if the water came from watering inside plants, or seeped in from the outside.

Tile at entry is missing grout in a couple of lines. Grout is water stained in the low lying area of the

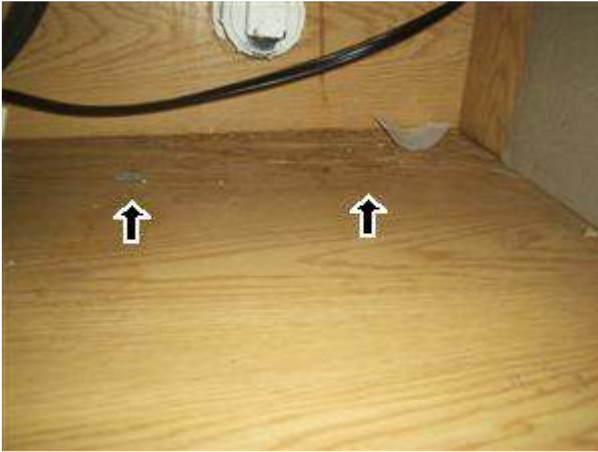
9.3 Picture 1 kitchen cabinet

Moisture stains noted to the under cabinet sink areas of the kitchen and the laundry room. No leaks were noted at time of inspection.

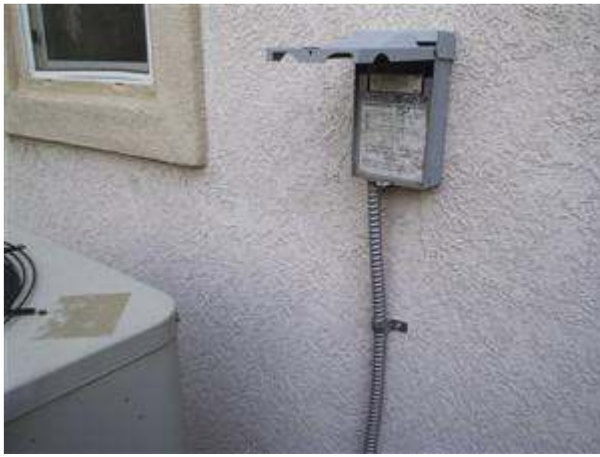
10.5 Picture 1 circuit breaker

Compressor/Condenser is located at the west side of the house. There is a 60 amp "pull type" fuse breaker at the location.

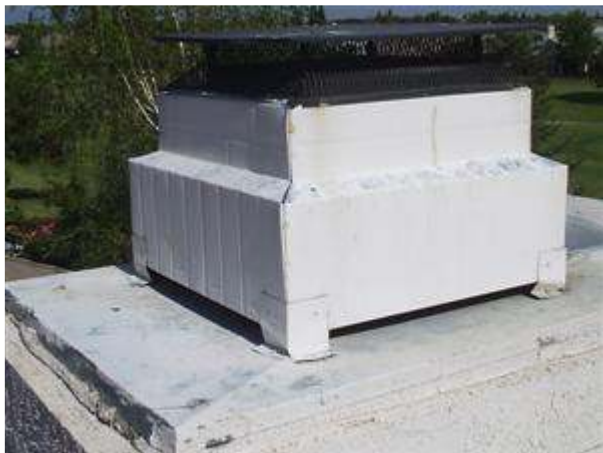
11.0 Picture 1 chimney cap

Chimney appears in good condition, sealed up well. Chimney was visually inspected from the lower end only, and appears clean. The cap is fastened securely to the chimney.

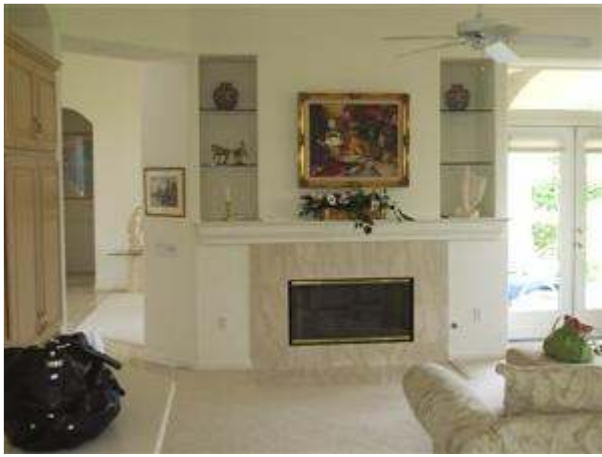
11.2 Picture 1 view of family room

Gas fireplace operated as intended. Operation requires an igniter stick, while turning the gas on.

The Fireplace system of this home was inspected and reported on with the above information but it is incomplete. The liner or the safety aspect of the liner was not inspected. The inspection is not meant to be technically exhaustive and does not substitute an inspection by a certified chimney sweep. The inspection does not determine the safety of the fireplace in terms of the condition of liner or the absence of a liner. Any comments made by the inspector does not remove the need for an inspection by a certified chimney sweep. Chimneys should be inspected at least annually. Please be aware that the inspector has your best interest in mind. Any repair items mentioned in this report should be considered before purchase. It is recommended that a certified chimney sweep inspect the liner for safe operation.
